## PATIENT INFORMATION ON BEARING SURFACES IN HIP

### What is a “metal hip”?

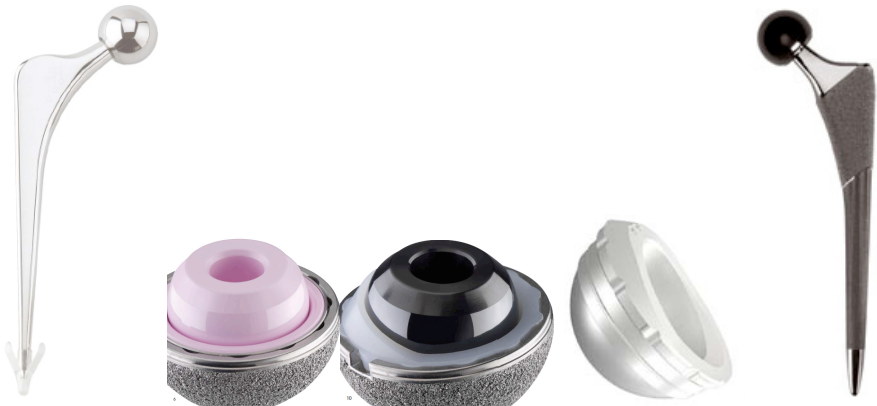
Above left is an example of a cemented metal stem (hip replacement) with a metal head, which traditionally articulated with a polyethylene liner as shown on the right (metal on poly bearing). Sometimes the liners have metal shells as seen in the examples showing a ceramic liner in a metal shell with a ceramic head (ceramic on ceramic bearing) and a polyethylene liner in a metal shell with a ceramicised metal (Oxinium) head (ceramicised metal on poly bearing). Right is an example of an uncemented metal stem (hip replacement) with a ceramicised metal (Oxinium) head.

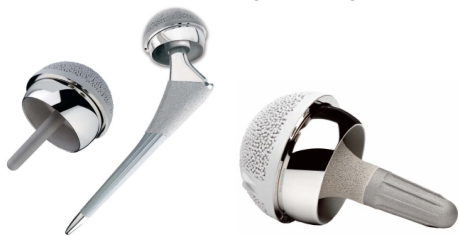
What the press are referring to when they broadly state metal hips is the bearing surface - a metal head rubbing against a metal cup liner. Below are examples of a BHR (resurfacing) left, a BHR on a stem middle and a BMHR (resurfacing) right. All have the same proven metal on metal bearing (Birmingham) which performs well.

As evident in the pictures the implants are almost identical to the casual observer. It was therefore assumed by DePuy that the ASR would perform the same as the BHR. There are however several critical flaws in the ASR design which have been proven in scientific articles to have lead to it's high risk of failure. These include those shown in the table below:
